DETROIT DIESEL

ATS Technician's Guide

NUMBER: 07 ATS-3 **S.M. REF.:** Listed in Table 1 **ENGINE:** ATS **DATE:** December 2007

SUBJECT: ADDITIONAL PROCEDURES WERE ADDED TO AFTERTREATMENT SYSTEM

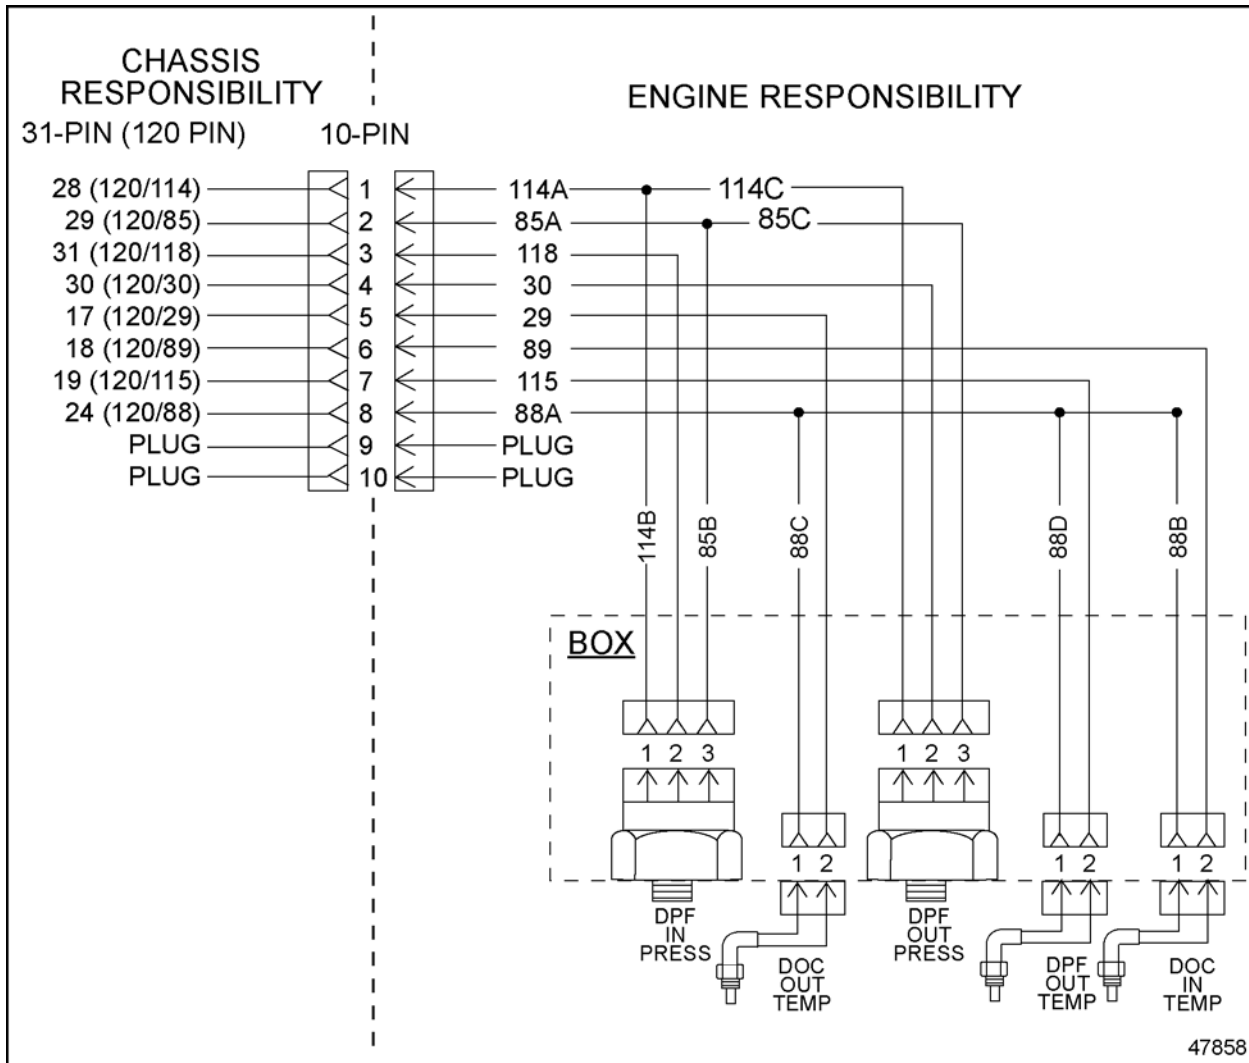
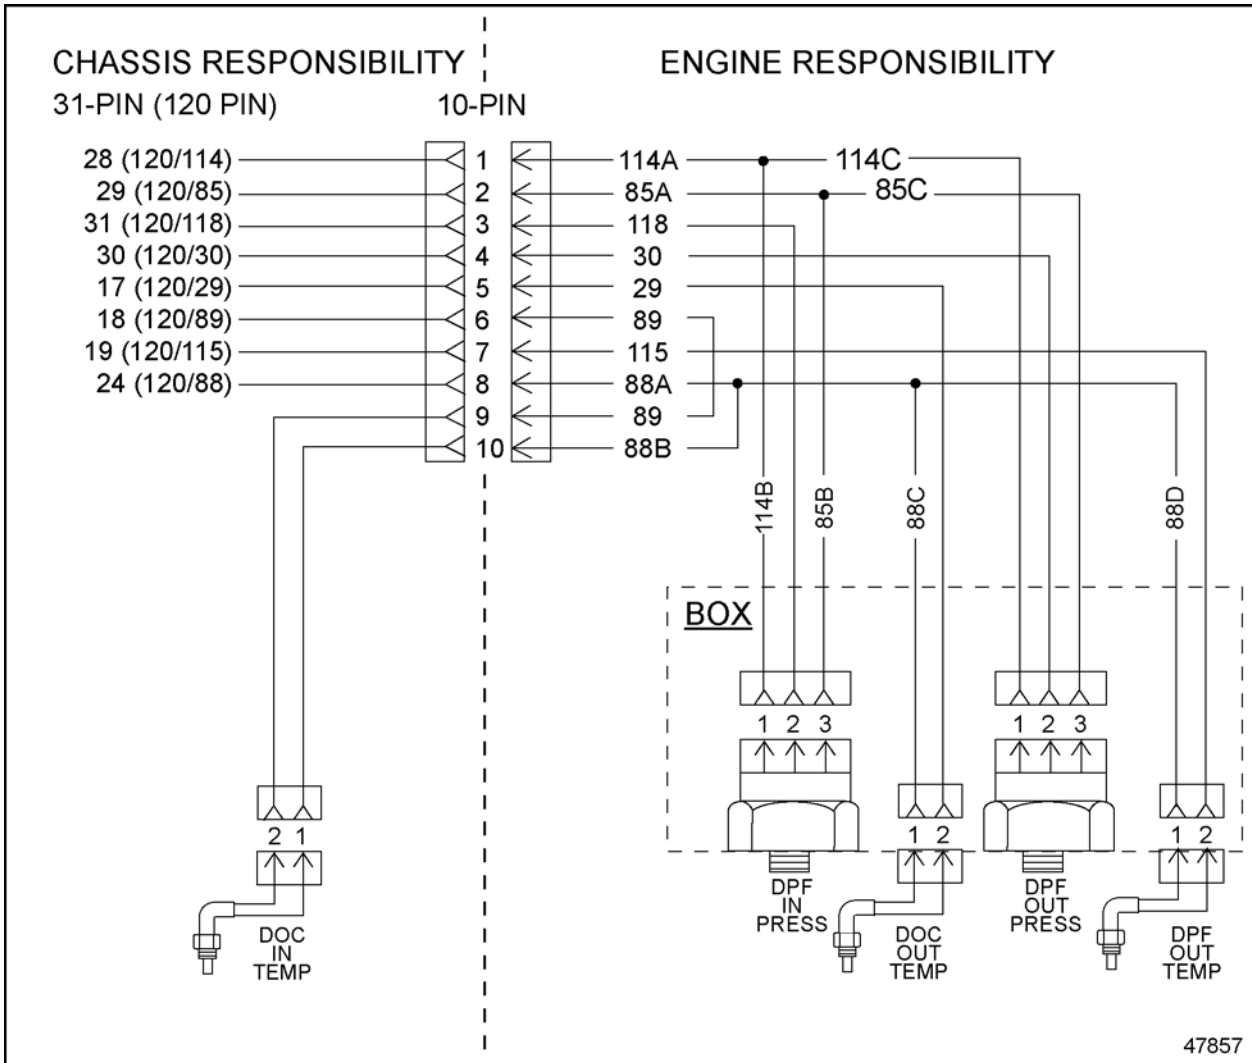
This diagnostic condition indicates the MCM has detected an impossible temperature shift on the DOC Inlet Temperature Sensor. The most likely cause is an intermittent wiring problem. See Figure 1 and Figure 2 for the ATD wiring schematics.

1. Connect DDDL 7.0 or later version.
2. Turn ignition ON (key ON, engine OFF).
3. Check for multiple codes.
 - [a] If fault 3242/3 or 3242/4 is active, troubleshoot this fault first. Verify repairs.
 - [b] If fault 3242/3 or 3242/4 and fault 3242/8 are inactive, go to step 4.

4. Start engine.
5. Access the Voltage Service Routine.
6. Select “Start Acquiring”.
7. Wiggle test the harness while looking for abnormal voltage spikes on T_DOC_IN (pin 89).
 - [a] If a voltage spike is detected, isolate that section of harness and inspect for wiring chaffing, corrosion, improper connections, or physical damage. Repair damage as necessary. Verify repairs.
 - [b] If no voltage spikes are seen, physically check and clean all harness connectors between the DOC Inlet Temperature Sensor and the MCM. Repair damage as necessary. Verify repairs.

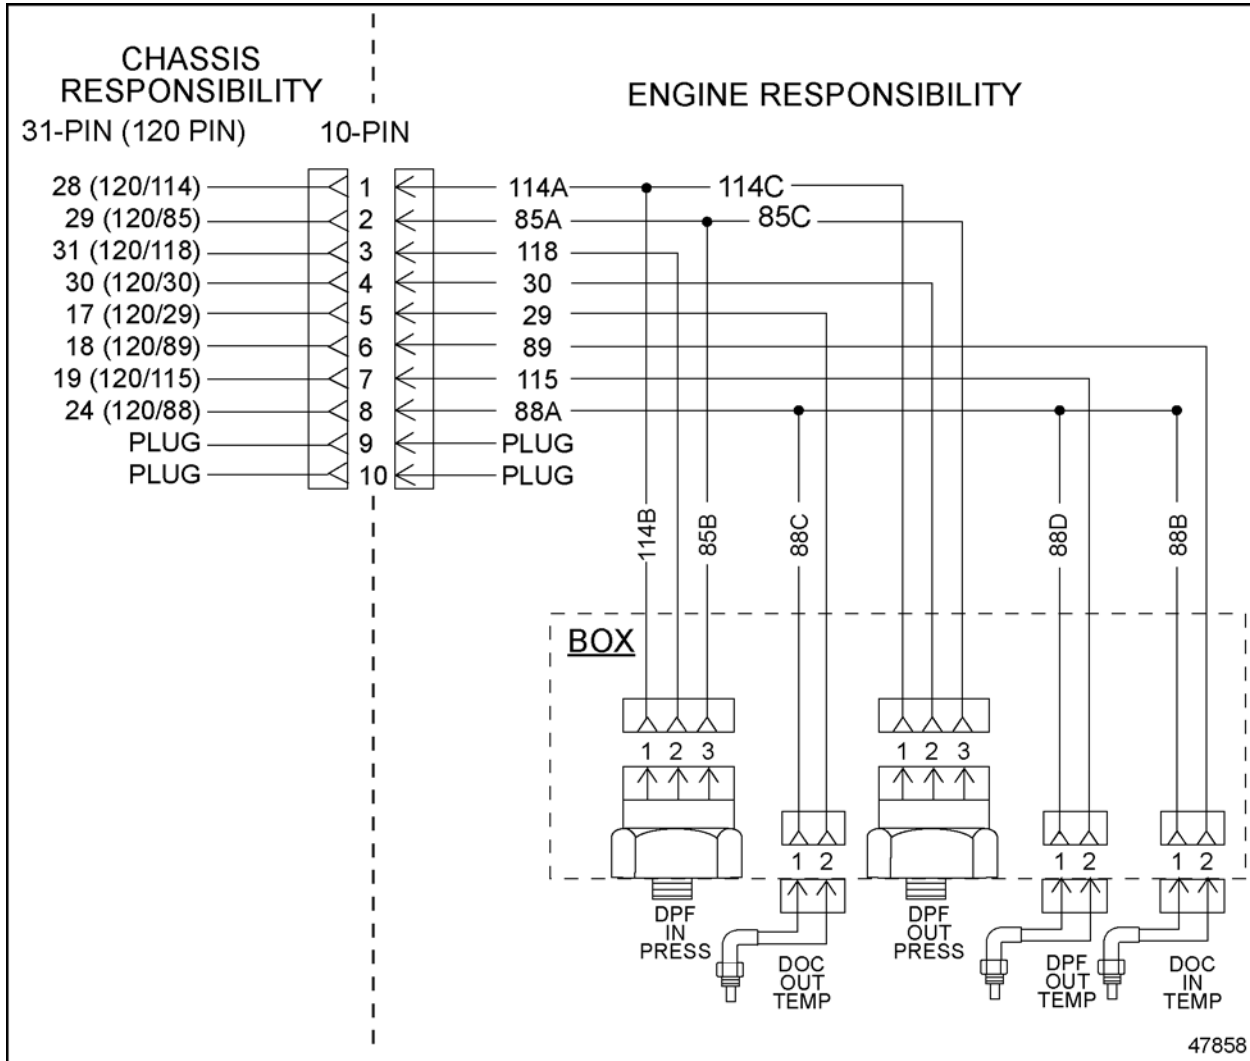
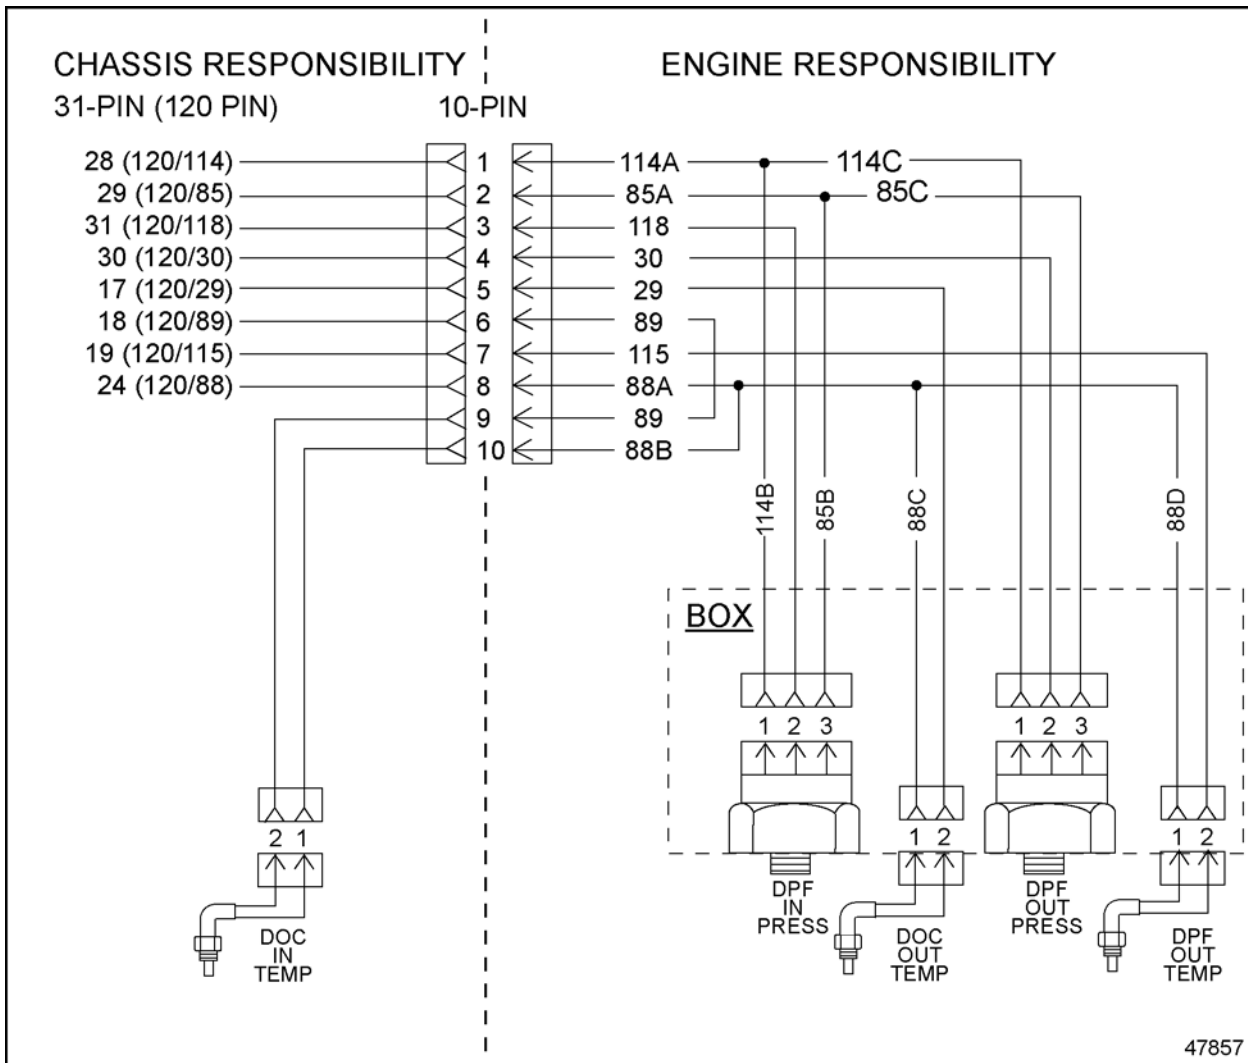
This diagnostic condition indicates the MCM has detected an impossible temperature shift on the DOC Outlet Temperature Sensor. The most likely cause is an intermittent wiring problem. See Figure 3 and Figure 4 for the ATD wiring schematics.

1. Connect DDDL 7.0 or later version.
2. Turn ignition ON (key ON, engine OFF).
3. Check for multiple codes.
 - [a] If fault 3250/3 or 3250/4 is active, troubleshoot this fault first. Verify repairs.
 - [b] If fault 3250/3 or 3250/4 and fault 3250/8 are inactive, go to step 4.

4. Start engine.
5. Access the Voltage Service Routine.
6. Select “Start Acquiring”.
7. Wiggle test the harness while looking for abnormal voltage spikes on T_DOC_OUT (pin 29).
 - [a] If a voltage spike is detected, isolate that section of harness and inspect for wiring chaffing, corrosion, improper connections, or physical damage. Repair damage as necessary. Verify repairs.
 - [b] If no voltage spikes are seen, physically check and clean all harness connectors between the DOC Outlet Temperature Sensor and the MCM. Repair damage as necessary. Verify repairs.

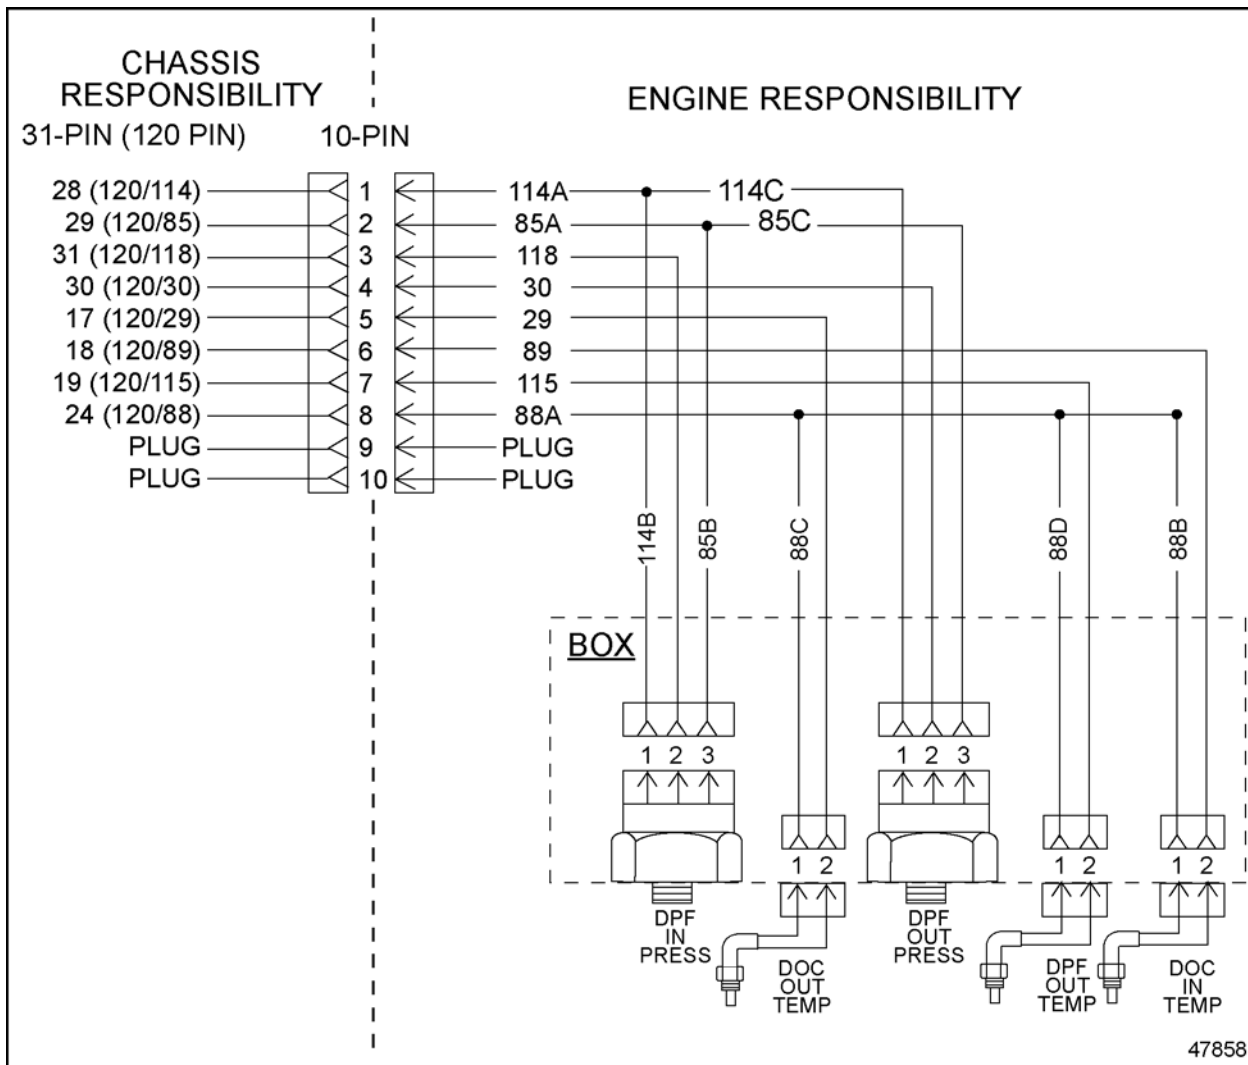
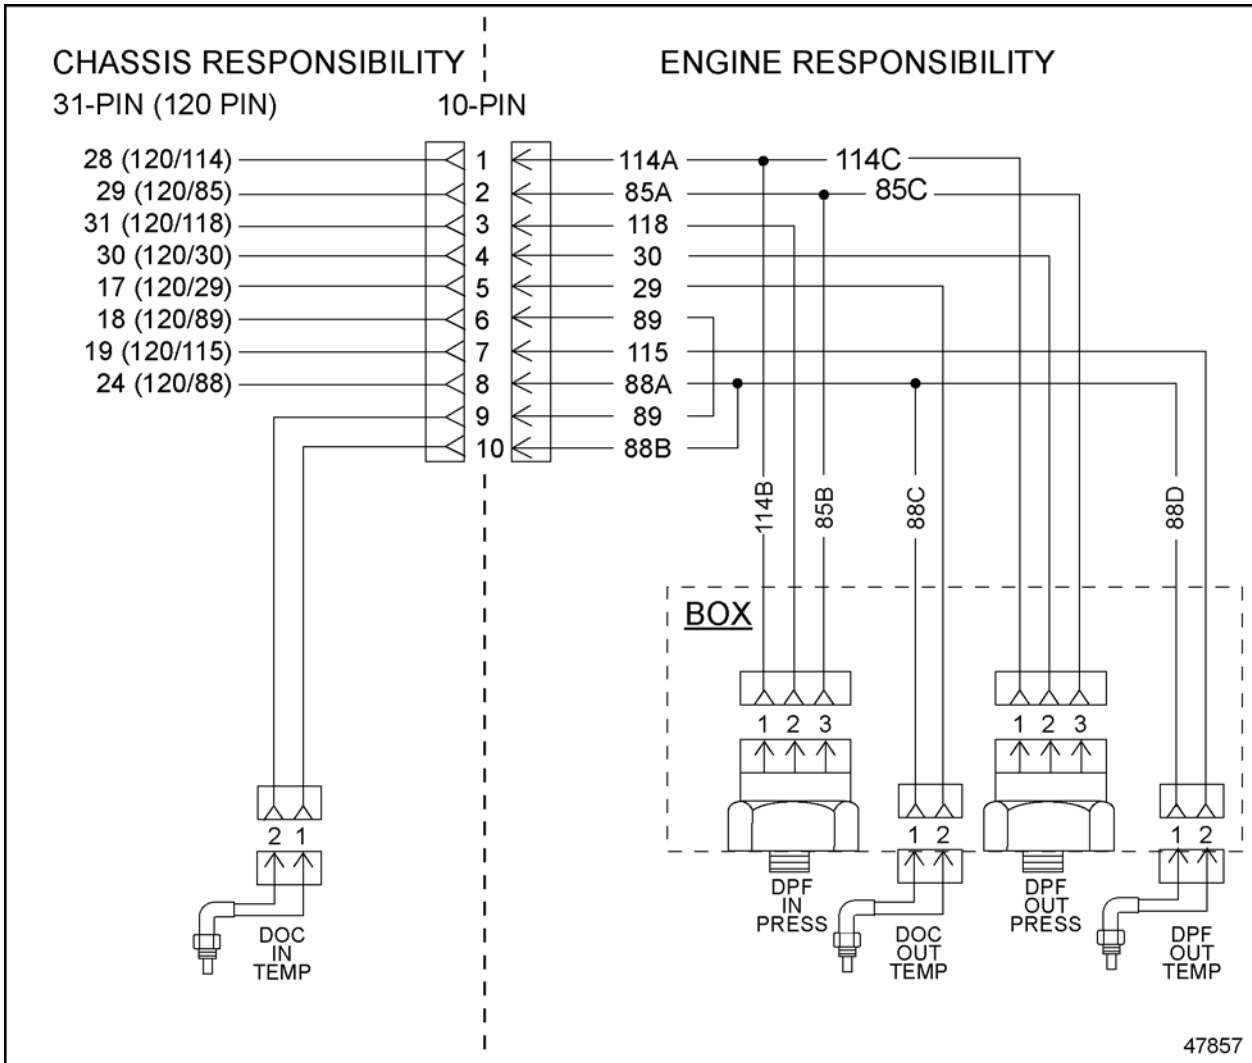
This diagnostic condition indicates the MCM has detected an impossible temperature shift on the DPF Outlet Temperature Sensor. The most likely cause is an intermittent wiring problem. See Figure 5 and Figure 6 for the ATD wiring schematics.

1. Connect DDDL 7.0 or later version.
2. Turn ignition ON (key ON, engine OFF).
3. Check for multiple codes.
 - [a] If fault 3609/3 or 3609/4 is active, troubleshoot this fault first. Verify repairs.
 - [b] If fault 3609/3 or 3609/4 and fault 3609/8 are inactive, go to step 4.

4. Start engine.
5. Access the Voltage Service Routine.
6. Select “Start Acquiring”.
7. Wiggle test the harness while looking for abnormal voltage spikes on T_DPF_OUT (pin 115).
 - [a] If a voltage spike is detected, isolate that section of harness and inspect for wiring chaffing, corrosion, improper connections, or physical damage. Repair damage as necessary. Verify repairs.
 - [b] If no voltage spikes are seen, physically check and clean all harness connectors between the DPF Outlet Temperature Sensor and the MCM. Repair damage as necessary. Verify repairs.
