## ATS Technician's Guide

**NUMBER:** 1 03-09   **S.M. REF.:** 12.1   **ENGINE:** ATS   **DATE:** January 2009

**SUBJECT:** SPN 3250/FMI 0

**PUBLICATION:** DDC-SVC-MAN-0036

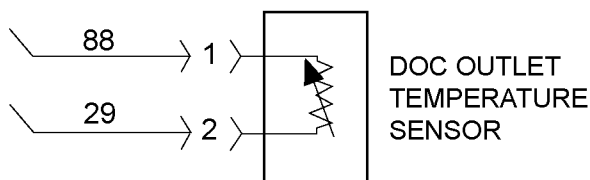
**Figure 1 DOC Outlet Temperature Sensor**

- 6. With DDDL 7.X connected, run the engine at 1200 rpm for 10 minutes.
- 7. Monitor DOC Inlet and Outlet Temperatures. Are the temperatures within 25°C (45°F) of each other?
  - [a] If yes, go to step 10.
  - [b] If no, go to step 8.
- 8. Turn ignition OFF.
- 9. Disconnect DOC Outlet Temperature Sensor and inspect connector for damaged, bent, spread, or corroded pins. If Temperature Sensor connector is OK, check connections upstream of the MCM (ATD harness 10-pin connector pin 5, VIH 31-pin connector pin 17, and MCM 120-pin connector pin 29). See Figure 1.

- [a] If harness damage is found, repair as necessary.
  - [b] If no harness damage is found, replace the DOC Outlet Temperature Sensor; refer to section "Temperature Sensor Removal."
10. Is the engine a Series 60?
- [a] If yes, go to step 11.
  - [b] If no, go to step 14.
11. Perform an Automatic Cylinder Cutout Service Routine using DDDL 7.X.

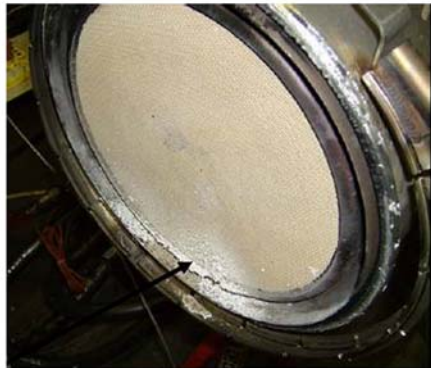
**Figure 2 DPF Inlet with Coolant Residue**

- [a] If coolant contamination is found (white residue on inlet face of the DPF and a sweet smell from exhaust), go to step 18. See Figure 2.

18. Question operator about coolant usage.
19. Visually inspect coolant reservoir for low level. Possible causes for coolant contamination in ATD are:
- EGR Cooler leaks

- Failed/defective cylinder head gasket, improper head bolt torque, low liner height
  - Failed Air Compressor cylinder head
  - Failed Fuel Cooler (HDE)

- Fuel Doser body cracked, missing or failed seals
20. Repair the cause of coolant entry as necessary and go to step 25.
